Shaking table tests of a one-quarter scale model of concrete hollow block masonry houses retrofitted with fiber-reinforced paint

Zamzam Multazam^{2✉}, Kenjiro Yamamoto¹, Kishor Timsina², Chaitanya Krishna Gadagamma¹ & Kimiro Meguro¹

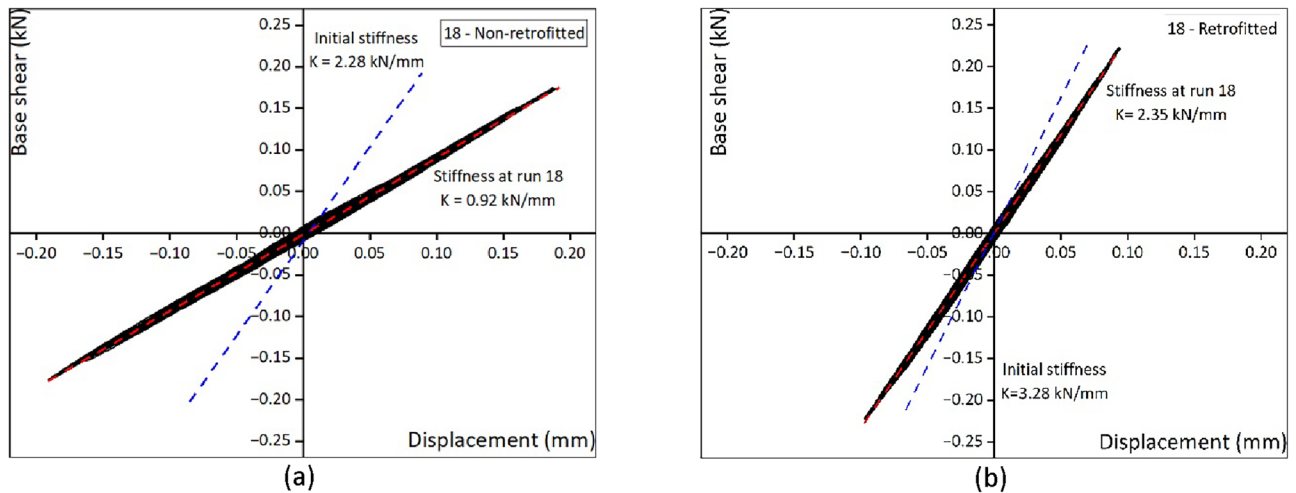
Figure 2. (a) Non-retrofitted at run 18 (0.1 g and 2 Hz), (b) retrofitted at run 18 (0.1 g and 2 Hz).

The behavior of the non-retrofitted and retrofitted house models was evaluated by plotting the measured displacement at the top (L4) (Fig. 1a) against the base shear. Figure 2 shows the hysteresis curve of non-retrofitted and retrofitted masonry house models, providing a visual representation of the force, displacement, and stiffness degradation. Figure 2 shows hysteresis curve of non-retrofitted and retrofitted house models, with the blue dashed line represents the initial stiffness of the house model obtained from the sweep test, whereas the red dashed line indicates the stiffness after run 18. This run was selected to compare the performance of both models in low frequency and amplitude. The non-retrofitted house model showed a peak displacement of ± 0.19 mm, which was higher compared to the retrofitted house model of ± 0.1 mm. Both models experienced a reduction in stiffness, where the non-retrofitted house model decreased from 2.28 kN/mm to 0.92 kN/mm, and the retrofitted house model decreased from 3.28 to 2.35 kN/mm. The reduction in stiffness indicates that the house model experienced cracking or damage on the masonry wall. However, in the retrofitted house model, the cracks were not visible as they were covered by the FR-Paint. The stiffness continued to decrease until the structure completely collapsed, the hysteresis curve for other runs is presented in Supplementary Figs. S6–S8.

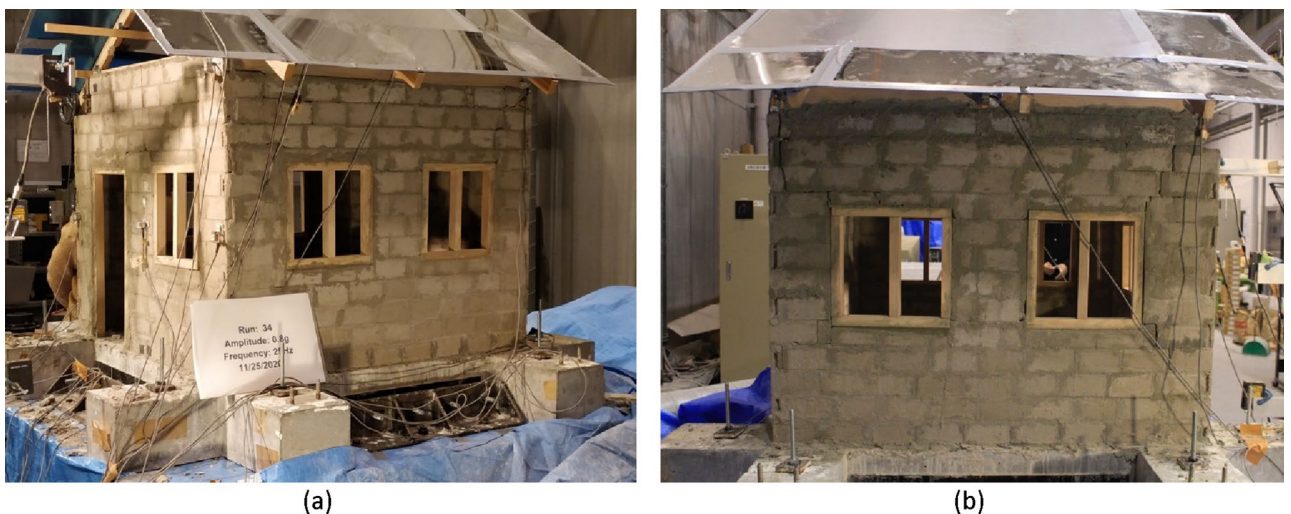
Figure 3. Cracks pattern of the non-retrofitted house model after run 34. (a) Out-of-plane failure on the north and south walls, (b) in-plane failure on the east and west walls.

Figure 3a shows the house model after run 34, the non-retrofitted house model sustained severe damage, with some blocks falling, particularly those located in the top left of the south wall. Vertical splitting cracks were observed in the north and south walls in an out-of-plane direction. This type of failure was not seen in the retrofitted house model. Figure 3b shows the east and west walls, subjected to in-plane loading, experienced significant cracking around openings. The presence of openings, such as windows, changes the stress distribution within the section, resulting in increased stress concentrations⁴⁵. This localized increase in shear stress has the potential to initiate diagonal cracks from the corners of windows. Cracks expanded and propagated from

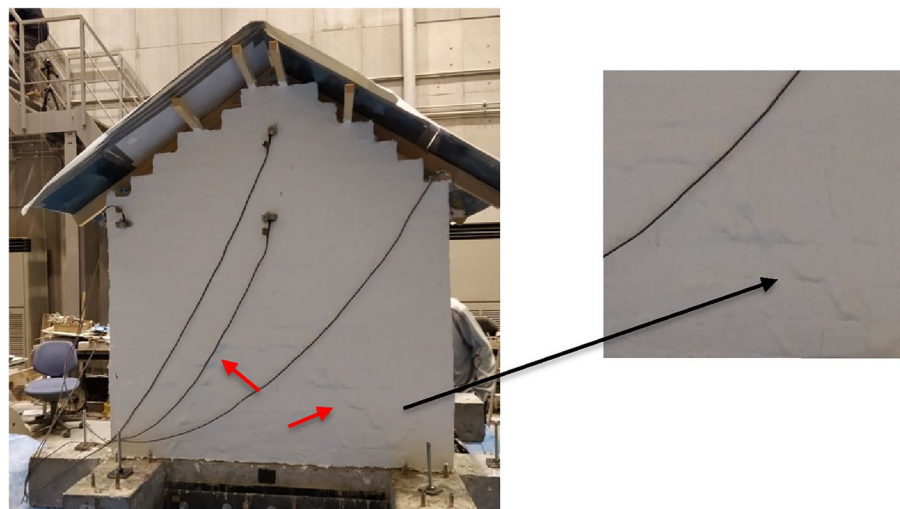
Figure 4. Cracking pattern of the retrofitted house model. The pictures were taken following the 48th run, and bubbles were forming on the surface of the masonry. The pattern resembles diagonal bubbles, extending from the bottom corners to the top of the masonry walls. Bubbles emerged on both the south and north walls, subjected to out-of-plane loading. Until this run, there were no indications of damage on the east and west walls in the in-plane direction.

Figure 4 shows the crack patterns and failure mechanism of the retrofitted house model subjected to various input motions. The retrofitted house model did not show any significant damage until run 36 (0.6 g and 20 Hz). The first sign of damage was observed at run 37 (0.8 g and 20 Hz), bubbles began to emerge on the wall surface due to cracks on the masonry surface and the delamination of the paint layer. After run 41 (0.4 g and 10 Hz), the bubbles were developing on the outside and inside of the masonry house. These bubbles enlarged and extended from the gable wall to the bottommost wall, eventually transforming into a rip in the subsequent runs (see Supplementary Fig. S12 online). Supplementary Fig. S13 shows a rip that appeared near the openings in the north wall after run 48 (1 g and 5 Hz), with no significant damage observed on the west and east walls. The gable wall was tied to the roof structure using FR-paint, and despite the partial detachment of the lowermost layer of the north and south walls from the base, the overall structures remained standing. After run 53 (0.8 g and 2 Hz), the south wall collapsed, but the whole house model remained standing even after some additional runs (see Supplementary Fig. S14 online). Even after run 55 (1.2 g and 2 Hz), there was no damage observed to the west and east walls. The retrofitted house model finally collapsed after run 56 (1.2 g and 2 Hz) at an intensity JMA of 7.

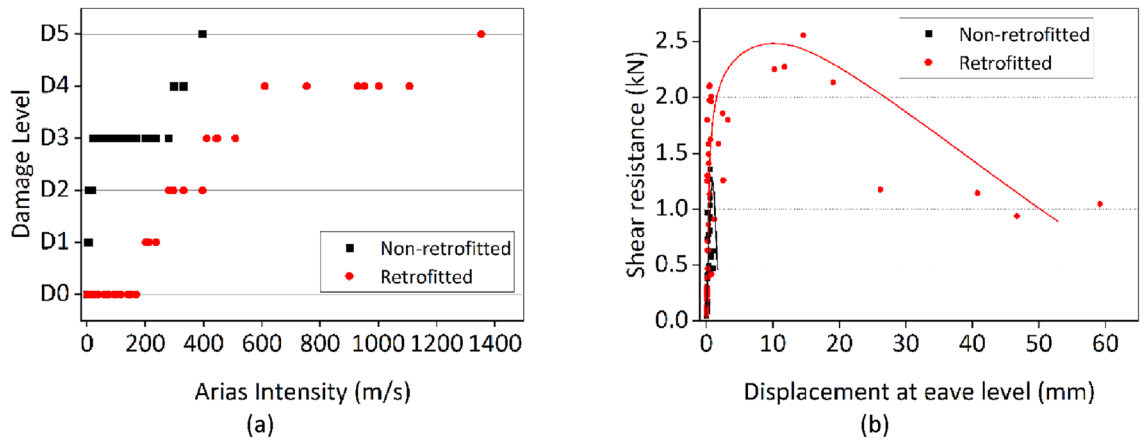
Figure 5. (a) Arias Intensity corresponds to damage levels D1–D5 based on the European macro-seismic scale, (b) shear resistance capacity.

The Arias intensity (I_a) measures the accumulated energy transferred to the structure through the ground motion during seismic events. It can serve as a measure of shaking intensity by integrating the cumulative ground motion intensity from the acceleration record at the base over the total shaking duration, which has been adopted in some studies^{14,35}. This measure assesses the total seismic energy absorbed by the ground⁴⁶. Figure 5a shows the performance levels of each specimen against various input motions. From the results, the retrofitted house model has the highest Arias intensity compared to non-retrofitted house model.

Figure 5b shows the relationship between shear resistance against maximum displacement at the eave level for both non-retrofitted and retrofitted house models. Shear resistance capacity involves evaluating lateral shear force acting on masonry house models during dynamic loading by comparing the maximum shear in the house model with the corresponding maximum eave displacement for each run. In small displacements, both non-retrofitted and retrofitted house models exhibited comparable lateral shear forces. However, as significant cracks

developed to the non-retrofitted house model, the shear resistance decreased, contrasting with the retrofitted house model that maintained a higher shear resistance. This observation highlights the impact of FR-Paint on the lateral resistance performance of the masonry structures. The lateral shear capacity of the retrofitted house model began to decrease at displacement of ± 15 mm, due to significant cracks and partial detachment of the bottom layer of the masonry wall from the foundation.

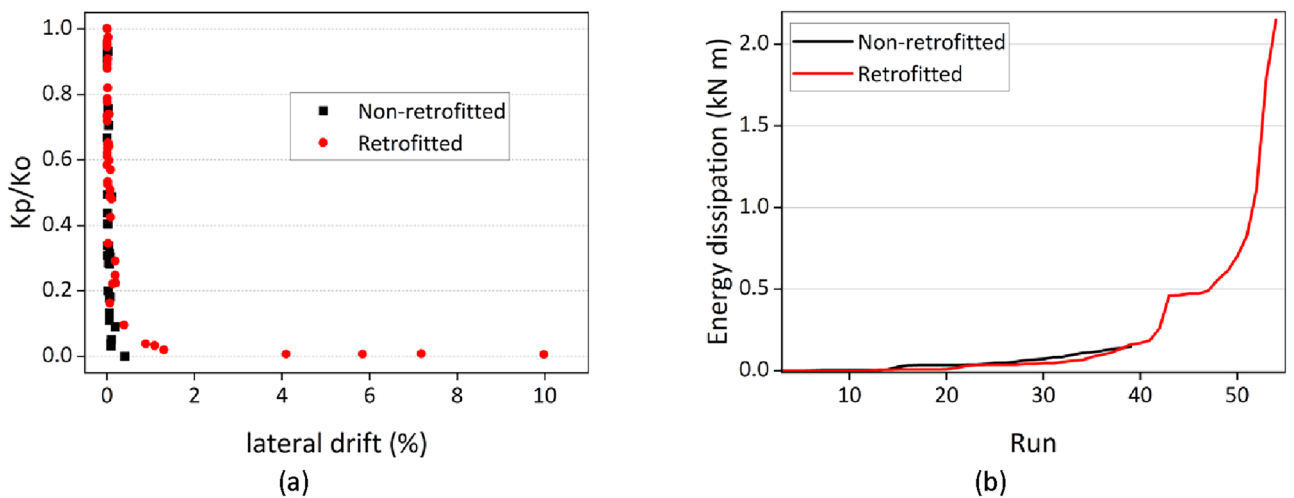
Figure 6. (a) Variations in the stiffness of the test models, (b) Cumulative energy dissipation of the house models.

The retrofitted house model outperformed non-retrofitted house model, demonstrating a higher displacement, as illustrated in Fig. 6a, which depicts a drift ratio of 9.97% for the retrofitted house model. At run 25, the non-retrofitted house model suffered heavy structural, marked by the collapse of gable walls on north and south sides, occurred at a drift ratio of approximately 0.193%. Some accelerometers from non-retrofitted house model were removed after run 37, and the highest recorded drift ratio was 0.4% at run 40. In contrast, the retrofitted house model showed structural integrity without exhibiting any signs of damage until run 36. The gable wall of the retrofitted house model was still attached to the structure until the entire wall collapsed. These results suggest a potential improvement of at least 18 times in the deformation capacity of reduced-scale masonry houses when

From Fig. 6a, the stiffness was related to the degree of damage to the masonry house model. The stiffness continued to decrease toward the end of the run as the masonry structures experienced more damage. The effective stiffness was defined as the slope of the hysteresis curve. The stiffness degradation of a masonry wall was evaluated by comparing the initial stiffness and final stiffness for each run. The initial stiffness (K_0) was calculated at the sweep run for both house models, and the final stiffness (K_p) was calculated for representative cycles in each run. Although the results of both sweep tests were almost the same, sweep test run number two was selected as it was applied before the actual input motion. Figure 2 and Supplementary Figs. S6–S8 show the hysteresis curve along with its corresponding slope for runs 18, 23, 37, 42, and 48. From Fig. 6a, reduced stiffness was observed even at a low drift ratio. Even in a small displacement shaking, the non-retrofitted house model experienced a displacement that was not restored to its original position. Despite the observation of the first sign of damage at run 37 in the retrofitted house model, the stiffness was already in decline, indicating that the masonry units within the paint had broken, and there was a loss of mortar bonds.

A comparison of results of energy dissipation capacities between the non-retrofitted and retrofitted house models for the corresponding run are shown in Fig. 6b. The energy dissipation capacity was evaluated by calculating the area enclosed within the hysteresis loops formed by the measure base shear and displacement at the top (L4). From Fig. 6b it is clear that the non-retrofitted house model had a very poor energy dissipation capacity, and heavy structural damage occurred to the model at low displacement. The retrofitted house model had a very high energy dissipation capacity. The dissipated hysteretic energy was mainly affected by the damage propagation mechanism. In the case of the retrofitted house model, the use of FR-Paint enhanced the integrity of masonry elements and prevented the house model from experiencing a sudden drop or brittle failure. In the non-retrofitted house model, the cracks propagated quickly after the first sign of the cracks. However, in the retrofitted house model, the crack propagated slowly. The energy dissipation capacity of the house model retrofitted with FR-Paint appeared to be at least 13 times larger than that of the non-retrofitted house model.
